**Flood Control Project Maintenance
Levee Inspections**

Maintenance Issue Types Only, Levee Inspection Report By Mile - Spring 2018

Reclamation District No. 0827 Elkhorn

Waterway	Bank	Unit Miles	Inspection Start/End	Inspector
Unit No. 01 Sacramento River	Right	1.34	04/19/2018 04/19/2018	Zach Jojola

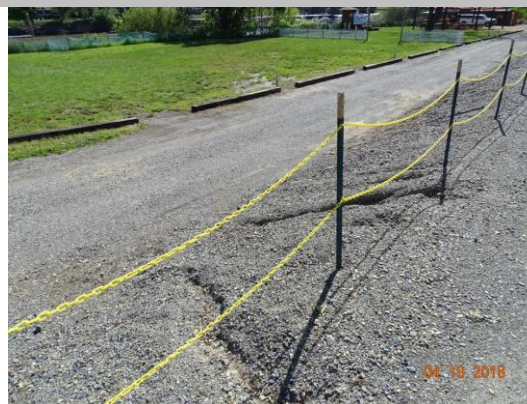
Photo 1 of 1 : SP_2018_RD0827_187_6_20180423_00016.jpg

LM Start	0.04	Rating **	A/W	Issue No.	6
LM End	0.04	Issue Type +	Ma	Location *	WS
Category	Earthen Levee			GPS Latitude/Longitude	
				Start	End
Item	Erosion / Bank Caving			38.674833 °	38.674833 °
				-121.630039 °	-121.630039 °
DWR ID	DWR_RD0827_01_s_2018_6				
Comment Code					
E1 : Note and monitor erosion site.					
Inspector Comment					
Small rills beginning to form on waterside slope. Recommend monitoring.

View of rills on the waterside slope. Spring 2018.

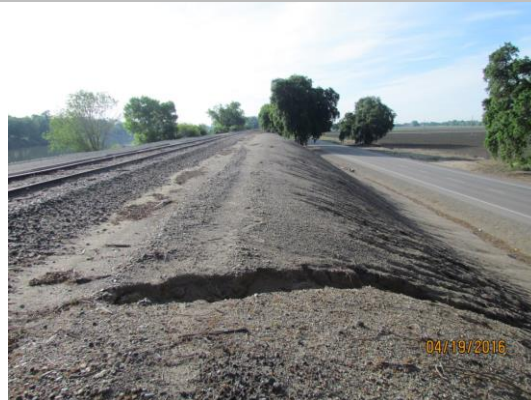
Photo 1 of 2 : SP_2018_RD0827_187_13_20180306_00006.jpg

LM Start	0.51	Rating **	M	Issue No.	13
LM End	0.51	Issue Type +	Ma	Location *	LS
Category	Earthen Levee			GPS Latitude/Longitude	
				Start	End
Item	Erosion / Bank Caving			38.669929 °	38.669929 °
				-121.623776 °	-121.623776 °
DWR ID	DWR_RD0827_01_s_2016_13				
Comment Code					
E2 : Schedule repair of erosion site prior to the next inspection.					
Inspector Comment					
Rills caused by rain.

View of the erosion on the landward side of the levee looking downstream. Spring 2016.

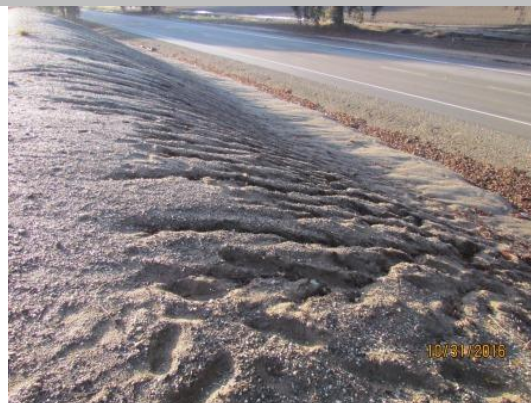
Photo 2 of 2 : SP_2018_RD0827_187_13_20180306_00007.jpg

LM Start	0.51	Rating **	M	Issue No.	13 (cont)	
LM End	0.51	Issue Type +	Ma	Location *	LS	
Category	Earthen Levee			GPS Latitude/Longitude		
				Start		End
Item	Erosion / Bank Caving			38.669929 °		38.669929 °
				-121.623776 °		-121.623776 °
DWR ID	DWR_RD0827_01_s_2016_13					
Comment Code						
E2 : Schedule repair of erosion site prior to the next inspection.						
Inspector Comment						
Rills caused by rain.

Updated view of runoff erosion site. LS slope. Fall 2016.

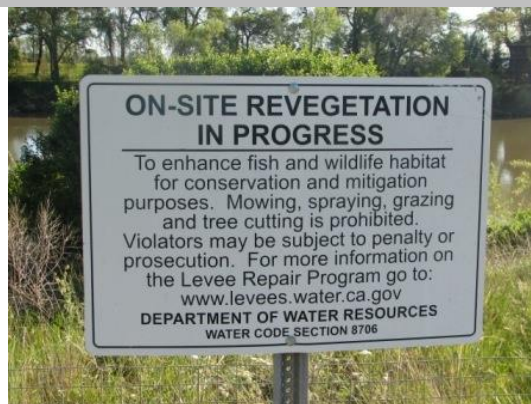
Photo 1 of 2 : SP_2018_RD0827_187_22_20180306_00010.jpg

LM Start	0.61	Rating **	A/W	Issue No.	22
LM End	0.92	Issue Type +	Ma	Location *	WS
Category	Earthen Levee			GPS Latitude/Longitude	
				Start	End
Item	Vegetation			38.668873 °	38.665750 °
				-121.622513 °	-121.618523 °
DWR ID	DWR_RD0827_01_s_2012_22				
Comment Code					
V8 : Environmental Requirements.					
Inspector Comment

Revegetation site spring 2012.

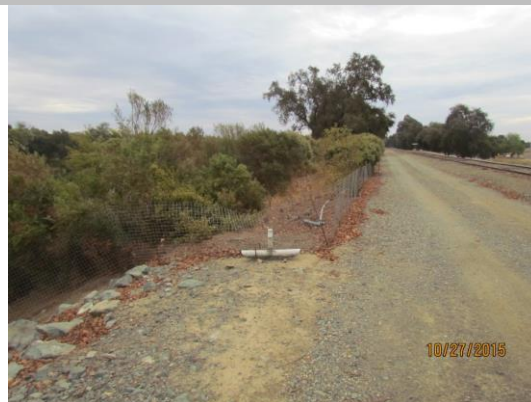
Photo 2 of 2 : SP_2018_RD0827_187_22_20180306_00011.jpg

View of the revegetation site on the waterward side of the levee looking downstream. Fall 2015.

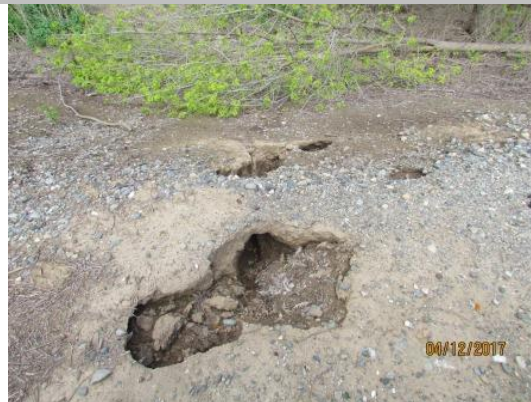
Photo 1 of 3 : SP_2018_RD0827_187_3_20180306_00001.jpg

LM Start	1.12	Rating **	M	Issue No.	3
LM End	1.12	Issue Type +	Ma	Location *	WS
Category	Earthen Levee			GPS Latitude/Longitude	
				Start	End
Item	Erosion / Bank Caving			38.663542 °	38.663542 °
				-121.616056 °	-121.616056 °
DWR ID	DWR_RD0827_01_f_2016_3				
Comment Code					
E2 : Schedule repair of erosion site prior to the next inspection.					
Inspector Comment					
Erosion on the crown and waterside slope from runoff.

Updated view of erosion on waterside levee slope. Spring 2017.

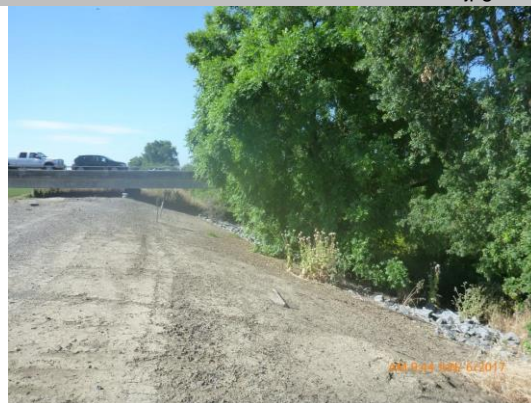
Photo 1 of 3 : LEVAL_SP_2018_200_1239.jpg

LM Start	0.15	Rating **	A/W	Issue No.	10	
LM End	0.16	Issue Type +	Ma	Location *		
Category	Supplemental			GPS Latitude/Longitude		
				Start	End	
Item	2017 Storm Damage			38.674778	°	38.674583
				-121.642806	°	-121.642722
DWR ID	DWR_RD0827_02_f_2017_10					
Comment Code						
Inspector Comment						
Levee Evaluation Comments						
Description:						
Site ID No:200						
Site Designation:RD 827-02						
Repair Type: Erosion						
Rating:Area of Concern						
Field Date:6/6/2017						
Notes: no damage visible, ws armored with riprap

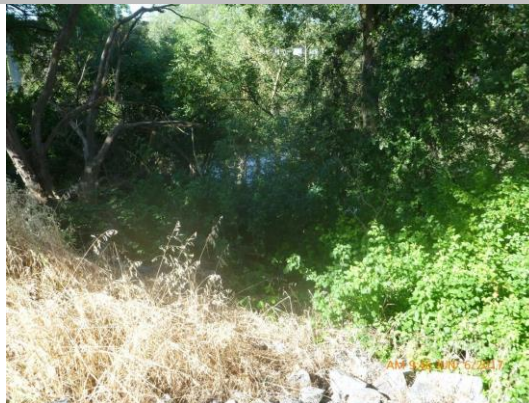
Photo 3 of 3 : LEVAL_SP_2018_200_1246.jpg

LM Start	0.15	Rating **	A/W	Issue No.	10 (cont)	
LM End	0.16	Issue Type +	Ma	Location *		
Category	Supplemental			GPS Latitude/Longitude		
				Start	End	
Item	2017 Storm Damage			38.674778 °	38.674583 °	
				-121.642806 °	-121.642722 °	
DWR ID	DWR_RD0827_02_f_2017_10					
Comment Code						
Inspector Comment						
Levee Evaluation Comments						
Description:						
Site ID No:200						
Site Designation:RD 827-02						
Repair Type: Erosion						
Rating:Area of Concern						
Field Date:6/6/2017						
Notes: no damage visible, ws armored with riprap

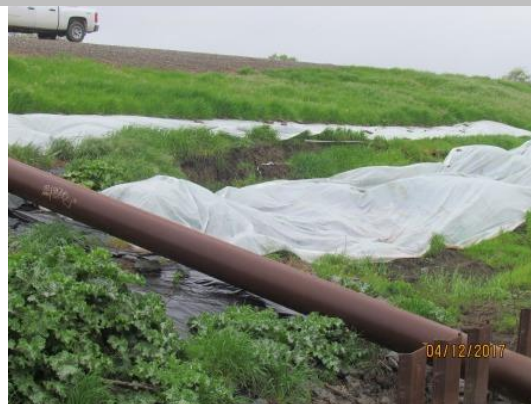
Photo 1 of 2 : SP_2018_RD0827_188_14_20180306_00013.jpg

LM Start	2.72	Rating **	A/W	Issue No.	14
LM End	2.74	Issue Type +	Ma	Location *	LS
Category	Earthen Levee			GPS Latitude/Longitude	
				Start	End
Item	Slope Stability			38.642088 °	38.641817 °
				-121.620972 °	-121.620802 °
DWR ID	DWR_RD0827_02_s_2017_14				
Comment Code					
Inspector Comment					
Slope stability on landside levee slope near LMA pump.

View of erosion and visqueen on landside levee slope. Spring 2017.

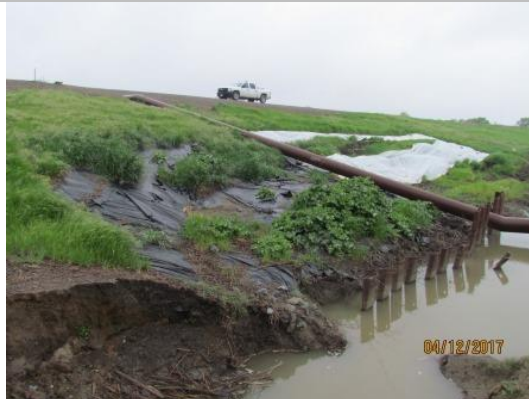
Photo 2 of 2 : SP_2018_RD0827_188_14_20180306_00014.jpg

LM Start	2.72	Rating **	A/W	Issue No.	14 (cont)
LM End	2.74	Issue Type +	Ma	Location *	LS
Category	Earthen Levee			GPS Latitude/Longitude	
				Start	End
Item	Slope Stability			38.642088 °	38.641817 °
				-121.620972 °	-121.620802 °
DWR ID	DWR_RD0827_02_s_2017_14				
Comment Code					
Inspector Comment					
Slope stability on landside levee slope near LMA pump.

Additional view of erosion on landside levee slope. Spring 2017.

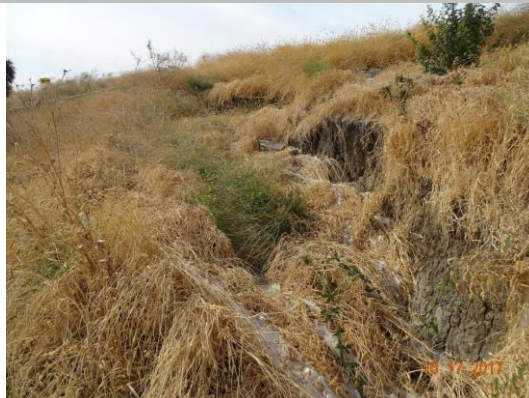
Photo 1 of 4 : SP_2018_RD0827_188_13_20180306_00009.jpg

LM Start	2.72	Rating **	M	Issue No.	13
LM End	2.73	Issue Type +	Ma	Location *	
Category	Supplemental			GPS Latitude/Longitude	
				Start	End
Item	2017 Storm Damage			38.642139 °	38.642028 °
				-121.620750 °	-121.620667 °
DWR ID	DWR_RD0827_02_f_2017_13				
Comment Code					
Inspector Comment					
Levee Evaluation Comments					
Description:					
Site ID No:199					
Site Designation:RD 827-01					
Repair Type: Erosion					
Rating:Area of Concern					
Field Date:6/6/2017					
Notes: landside. Visqueen has dried up and is no longer protecting the slope.

Updated view of sloughing on landside slope. Fall 2017.

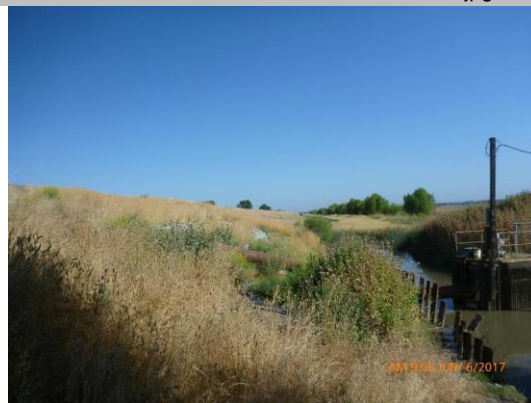
Photo 2 of 4 : LEVAL_SP_2018_199_1231.jpg

LM Start	2.72	Rating **	M	Issue No.	13 (cont)	
LM End	2.73	Issue Type +	Ma	Location *		
Category	Supplemental			GPS Latitude/Longitude		
				Start	End	
Item	2017 Storm Damage			38.642139 °	38.642028 °	
				-121.620750 °	-121.620667 °	
DWR ID	DWR_RD0827_02_f_2017_13					
Comment Code						
Inspector Comment						
Levee Evaluation Comments						
Description:						
Site ID No:199						
Site Designation:RD 827-01						
Repair Type: Erosion						
Rating:Area of Concern						
Field Date:6/6/2017						
Notes: landside. Visqueen has dried up and is no longer protecting the slope.

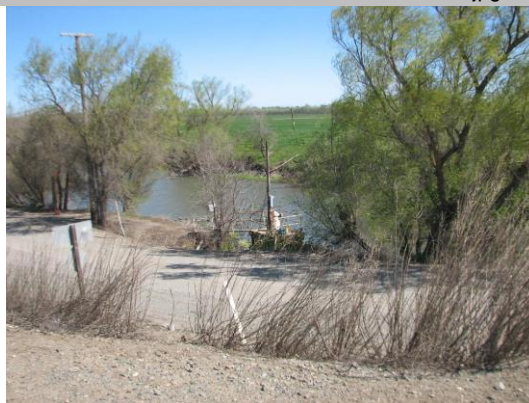
Photo 2 of 3 : UCIP_SP_2018_33032_59777.jpg

FS_ID:33032
DS_ID:21169
EP_NO: 5611
Repair Type: Non-Urgent
Crossing Status: Found
UCIP Comments: Crossing appears to have been removed and replaced under maintenance back in 2008. No permit has been found--need to contact owner to obtain additional information about replacement.
FIELD_STRUCT_DESC: [RD No. 827 Pumping Plant] 22-inch (not 24-inch as mentioned in desk study) steel drainage pipe through the levee, 8 feet below the crown. Corrugated metal cutoff wall around pipe at center of levee. Siphon breaker on waterside (WS) slope. Flap gate on WS end. Pipe is exposed along WS slope. (portion of pipe was removed and replaced, from landside to waterside shoulder, under Permit No. 5611 (1968)). [Additional Reference(s): DWR Levee Logs, 2005. USACE Sacramento O&M Manual Unit No. 122 Part No. 1, August 1955, (Station 3+75)]
FS Date: 3/18/2014

Pump station located on landward side.

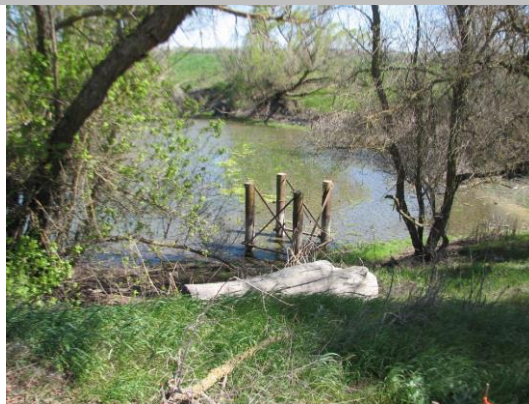
Photo 3 of 3 : UCIP_SP_2018_33032_59776.jpg

Reminisce piles located on landward side.
